This is a follow-up to a field advisory issued by our valve supplier, RegO, on Friday, February 3, 2017 covering L7579 1-3/4" ACME x 1-1/4" MNPT Filler Valves with Date Codes 08B16 to 01C17. RegO has identified there have been some reports where delivery personnel had difficulty disconnecting from the L7579 Filler Valves after filling has been completed.

FIELD ADVISORY

L7579 1-3/4" X 1-1/4" MNPT Filler Valve Date Codes 8B16 to 1C17

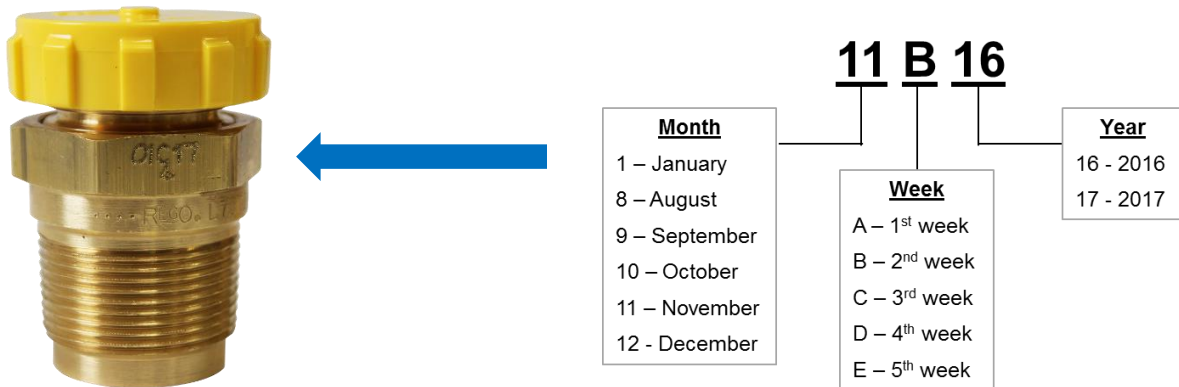
Date Code Identification

The dates of manufacture of the valves covered by this field advisory are August second week 2016 (8B16) to January third week 2017 (1C17).

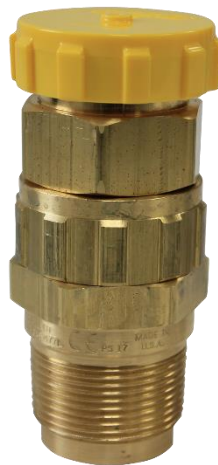
L7579 with a 3179B installed.

It is a good practice to use filler hose adapters like the 3179B when conducting any filling operation into a 1-3/4" ACME filler valve. When a filler hose adapter is attached to the hose end valve connection during the filling process and there is a problem disconnecting due to leakage through the upper check, the 3179B or other type filler hose adapters can remain on the subject filler valve. This will allow the delivery person to safely disconnect the hose end valve from the filler hose adapter which will remain connected to the subject filler valve leak free.

Do not attempt to fill or refill any container that has a L7579 with date codes of 8B16 to 1C17 without first installing a filler adapter (similar to 3179B) on 1-3/4" ACME fill connection of L-7579 filler valve covered by this advisor.
